- **Location:**
Royal Oak, Michigan
- **Profile:**
Water Intrusion
- **Project:**
Below-Grade Evaluation

Beaumont Health Systems Royal Oak Campus

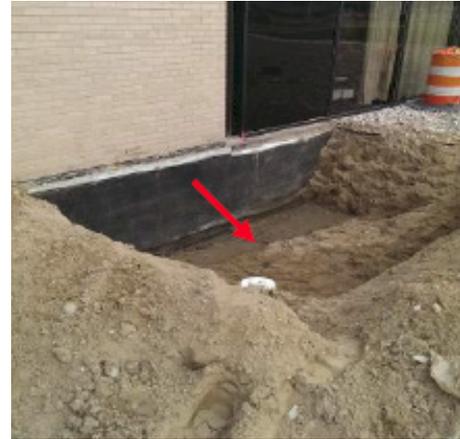
StructureTec performed an interior observation and found that no leakage was present at the time of the observation. We then performed an exploratory excavation along the exterior building wall of the Southeast corner. The excavated material consisted primarily of sand, and moisture was found in the residual sand layer over the basement corridor roof.

Overview of exploratory excavation at Southeast side of North Tower

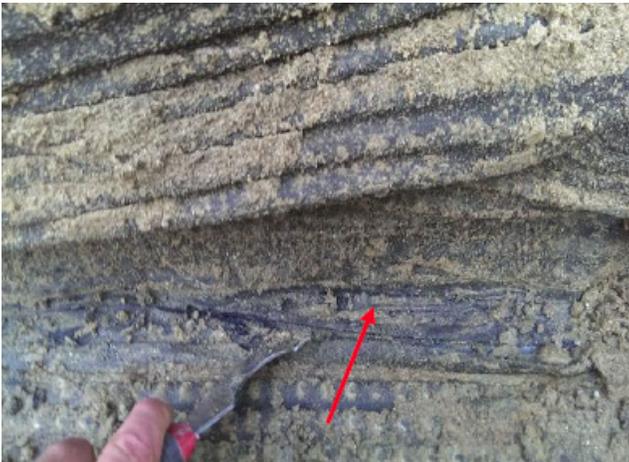
crete construction and tie-ins of later additions. Terminations and corner details were not installed properly, compromising the integrity of the waterproofing system. The waterproofing membrane detail at the inside corner, where the basement corridor roof slab and the main building basement wall intersect, had been installed without a cant or transition radius. This condition increased the possibility of membrane failure over time.

Drainage composite was not properly lapped at building wall-to-corridor roof transition. Membrane was not supported by a cant or curved fillet at the transition.

- Excavating and exposing the existing below-grade waterproofing system around the addition where it ties to the North Tower
- Reviewing and repairing deficient membrane transition details at corners and construction joints
- Providing reglet-set counter flashing along the top edge of the North Tower building wall waterproofing

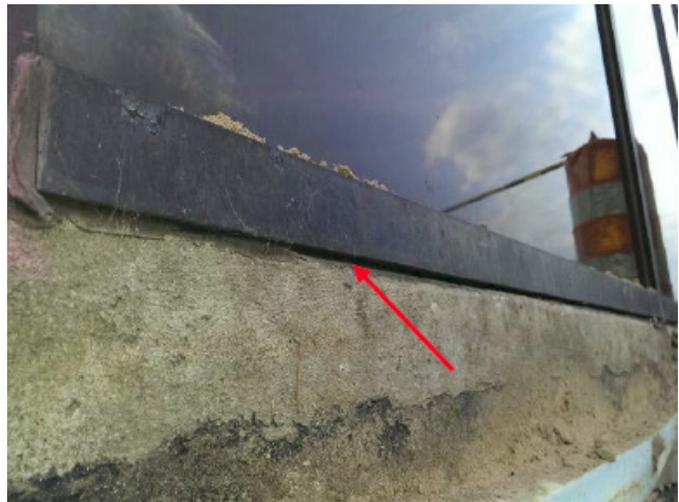
Cool interior air was flowing out of the building along storefront glazing sill at the 1st floor slab surface.

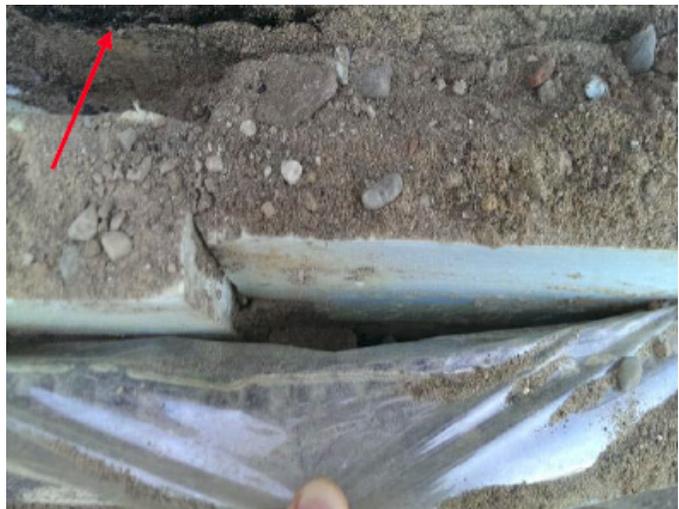
Detail view of building wall waterproofing system. Waterproofing material applied to wall (arrow) followed by rigid insulation and drainage composite layer.
