- **Location:**  
Kalamazoo, Michigan
- **Profile:**  
Medical Building
- **Project:**  
Exterior Wall Restoration

## Borgess Medical Center Main Complex - South Tower

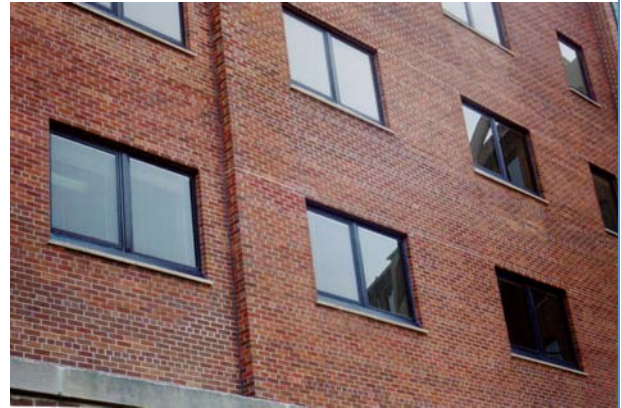
Overview of completed wall restoration.

solid support for the exterior brick. New masonry units were installed to provide a structurally sound, weatherproof exterior wall. As Construction Manager, StructureTec was able to fast-track the project and coordinate the subtrades, therefore providing the proper sequencing and scheduling to meet the project criteria. BMC benefitted by having only one contact with which to communicate because of the

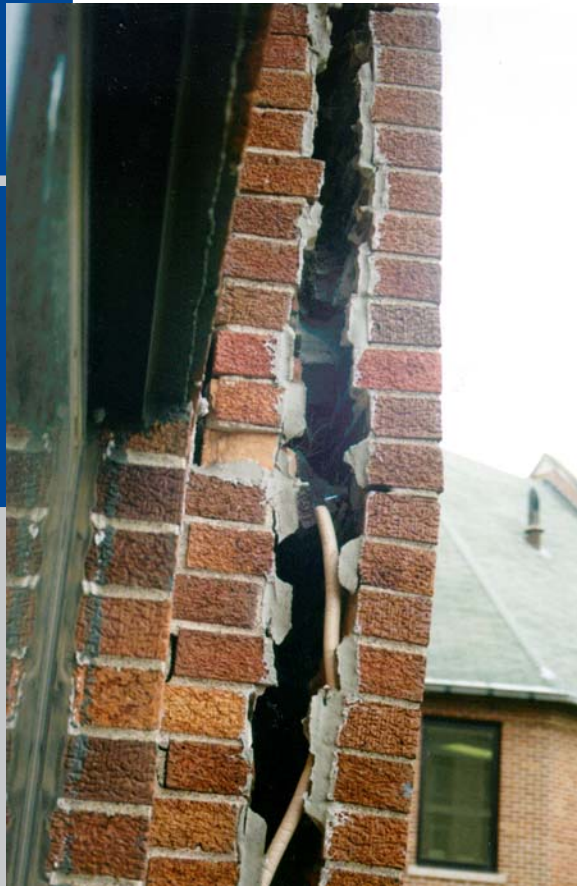
Exterior masonry brick is pulling away from interior wythe.

Services to analyze the initial problem and to develop a strategy for corrective action. During the evaluation, it was noted that the problem was being caused by missing and deteriorated masonry wall ties/anchors which had never been completely sealed. This had been a progressive failure over time and several attempts had been made to simply caulk the openings. These repairs failed to address the cause of the problem. The moisture ingress continued, and after numerous freeze/thaw cycles over multiple seasons, this ingress had spurred several problems. Degradation had occurred to the masonry units, but the primary cause of the distress was due to the corrosion of the metal ties which were no longer able to hold the masonry units in place.

As Construction Manager, StructureTec solidified a contractor the next day and demolition began that Friday afternoon. The demolition continued over the weekend and involved removing existing masonry units and ties, as well as providing temporary weatherproofing. Simultaneously, StructureTec was involved with the corrective design and details. By Monday morning, the reconstruction of the wall began. New masonry ties were installed to provide

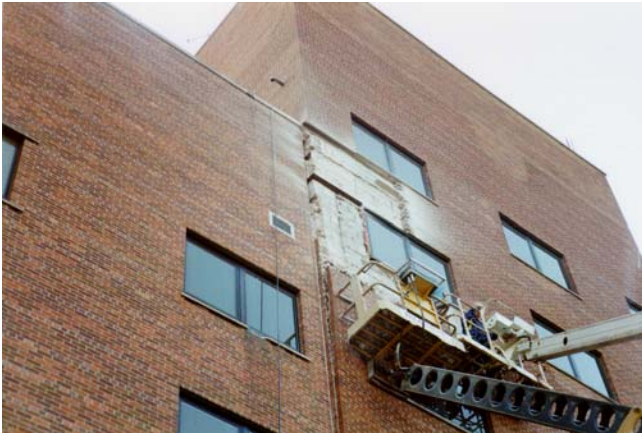
Overview of work in progress.

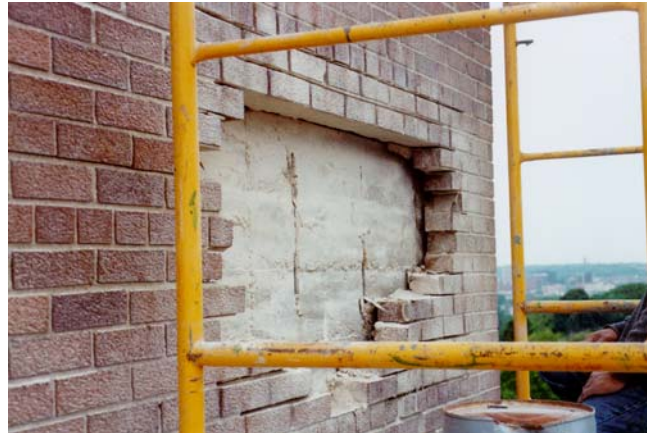
Demolition included removing degraded masonry units and ties.
