University of Pittsburgh Medical Center

Western Psychiatric Institute and Clinic

Horizontal Restoration - Institution

StructureTec® Project Profile

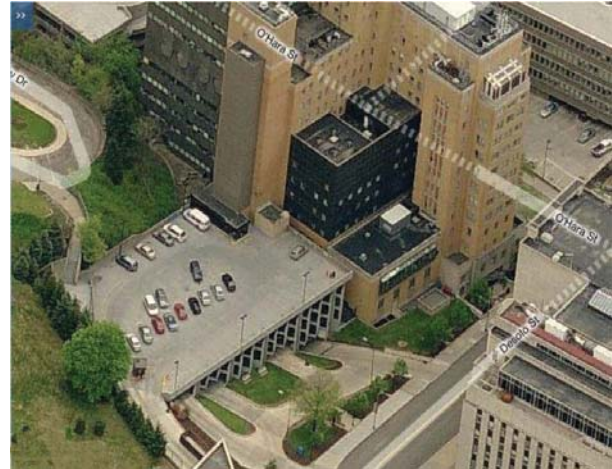
Overview of University of Pittsburgh Medical Center - Western Psychiatric Institute & Clinic parking deck

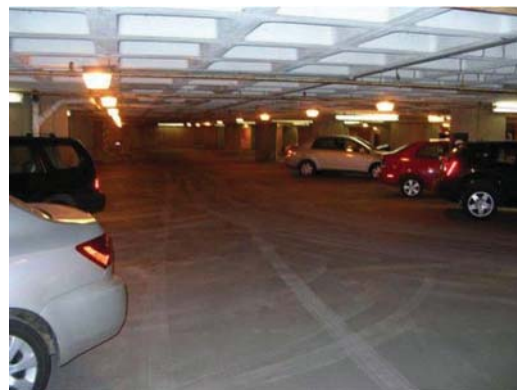
ture. There was the potential for fall/life safety hazards from spalled/cracked concrete, which required immediate attention.

Overview of Western Psychiatric Institute & Clinic parking structure level 2

The spalled and cracked concrete needed to be removed, and restoration and weatherproofing of concrete needed to be performed to prevent additional deterioration. In order to restore the structure back to original sound materials, other procedures like routing and sealing of cracks, exposing and coating corroded embedded steel reinforcement, and providing concrete repair were crucial for these levels.

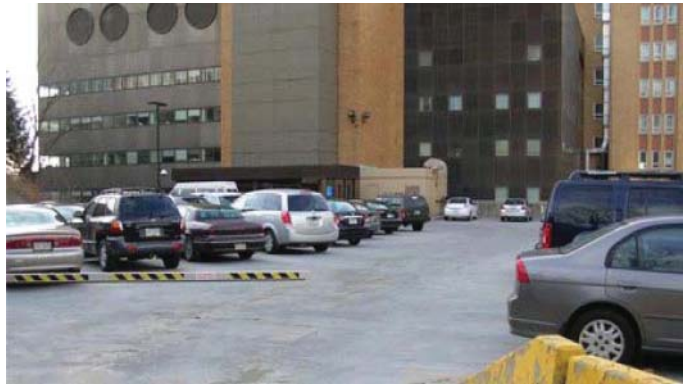
repairs were required to address the deteriorated concrete, which resulted in significantly corroded reinforcing steel. In addition to the extensive concrete deterioration, the primary challenge on level five was the blistered/delaminated coating on the parking deck driving surface. As a result, the existing traffic-bearing coating was completely removed and replaced.

Partial overview of level 5 of the parking structure

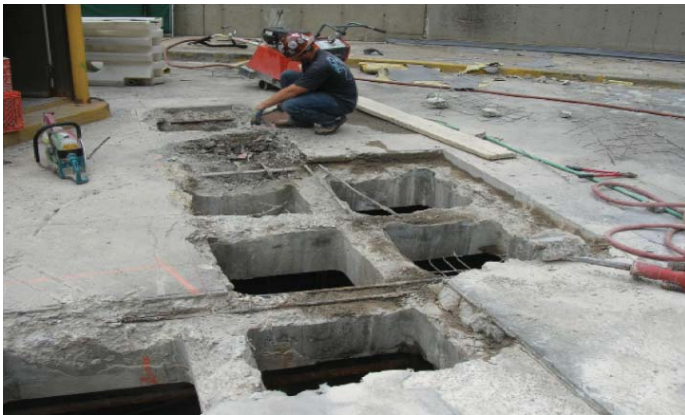
Western Psychiatric Institute & Clinic parking structure construction
